# Case Study: Marina in Switzerland after 38 years

Source: Galvanizers Association

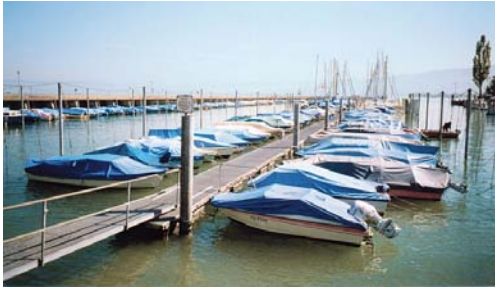
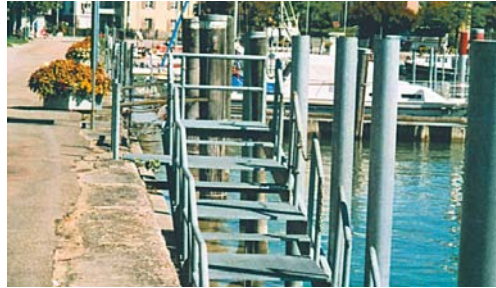
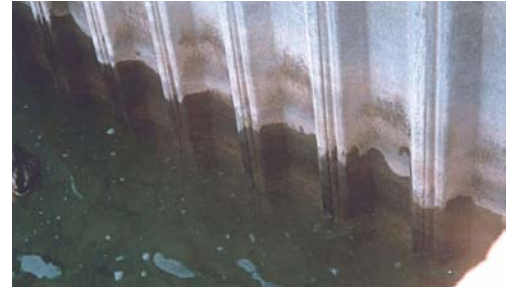
A second inspection of the two port installations took place in the autumn of 2006 about 38 years since the original construction project. The galvanized coating was again shown to be in good condition and fully functional. As expected, the original silvery, glossy zinc appearance had changed into a dull grey surface. This change in appearance occurs as the protective film is built up on the coating surface during reaction with the atmosphere.

The inspection report emphasised the good condition of the sheet piling after so many years of exposure, despite the exposure to abrasion and impact from boats. In fact, it was only on some steel bollards, to which large ships moor up using heavy chains, that the galvanized coating had been damaged. The electrochemical protection of the surrounding zinc will prevent this damage from spreading through sideways corrosion.

Most importantly, the inspected thicknesses of the remaining coating was still between 50 and 100  $\mu\text{m}$ . So, the galvanized steel elements of these port installations will also remain protected against corrosion for many more years to come.
